# Manhole Inspection Summary

Manhole # S19G\_\_022MH

Insp Date: **10/9/07 11:09 AM**

**Location** Address: **1943 VINE ST**

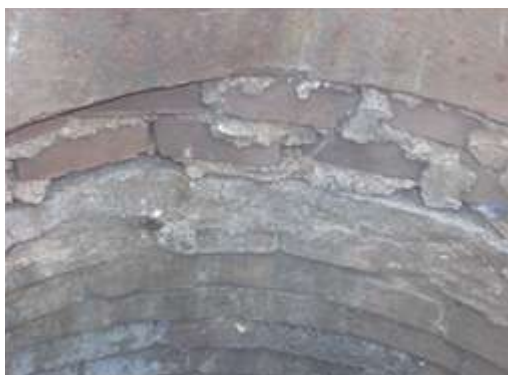
Defect 1

Condition: ☐ Sound ☐ Cracked ☐ Root Intrusion ☒ **Loose Brick** ☐ Deteriorated

LOOSE CHIMNEY BRICKS

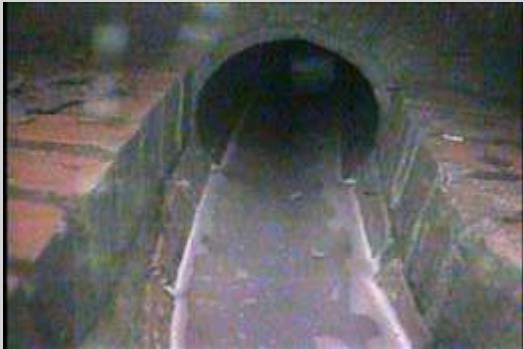
12 O'Clock Outflow

10 in. Circular Gravity Sewer  
Pipe Out @ 12 O'Clock

Pipe Height: **10.8** (in.) Rod and Bar (Angled)  
Pipe Material: **Clay** ☐ Pipe Lined  
Invert Depth: **11.67** (ft.) Flow Characteristics: **Slow**  
Deposits: ☒ None ☐ Mud ☐ Sludge ☐ Debris ☐ Grease  
Silt Depth: (in.) Deposits Extent:  
Infiltration: **None** Pipe Seal Cond: **Sound**

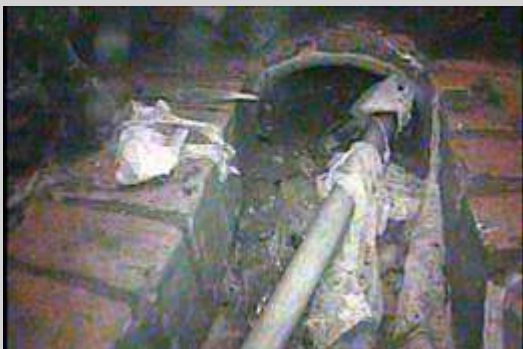
4 O'Clock Inflow

10 in. Circular Gravity Sewer  
Pipe In @ 4 O'Clock

Pipe Height: **10.8** (in.) Rod and Bar (Angled)  
Pipe Material: **Clay** ☐ Pipe Lined  
Invert Depth: **11.67** (ft.) Flow Characteristics: **Slow**  
Deposits: ☒ None ☐ Mud ☐ Sludge ☐ Debris ☐ Grease  
Silt Depth: (in.) Deposits Extent:  
Infiltration: **None** Pipe Seal Cond: **Sound**

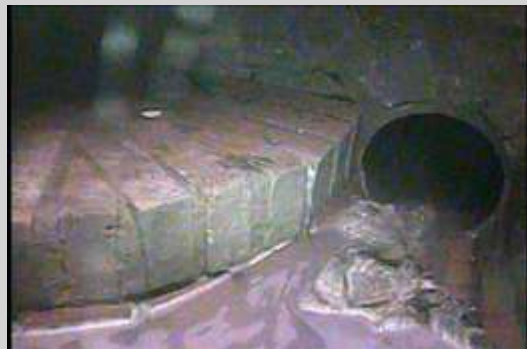
9 O'Clock Inflow

8 in. Circular Gravity Sewer

Pipe In @ 9 O'Clock

Infiltration: **None** Pipe Seal Cond: **Sound**
